# FINAL REPORT

## Dry Gulch Stream Restoration

Biological and Agricultural Engineering Department  
North Carolina State University  
Raleigh, North Carolina

Town of Carrboro  
Carrboro, North Carolina

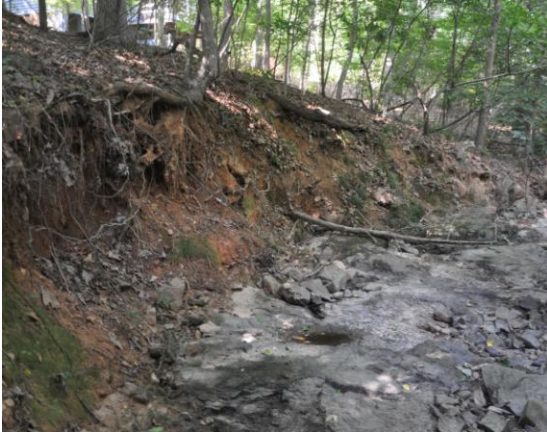
Photograph 1. Eroding hillslope before construction.

Approximately 150 feet of channel was relocated away from an eroding hillslope and sewer easement. A new channel was constructed, the gravel and cobble bed material was transferred from the old channel, then flow was turned into the new channel. The old channel adjacent to the eroding hillslope was filled in and stabilized. (Photographs 1 - 4).

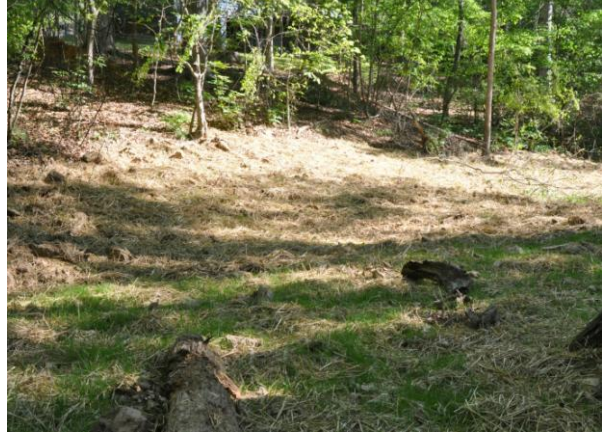
Photograph 2: Old channel filled in and eroding hillslope stabilized

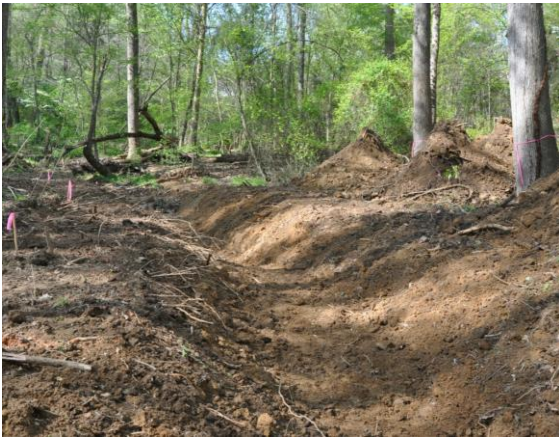
Photograph 3: New channel constructed

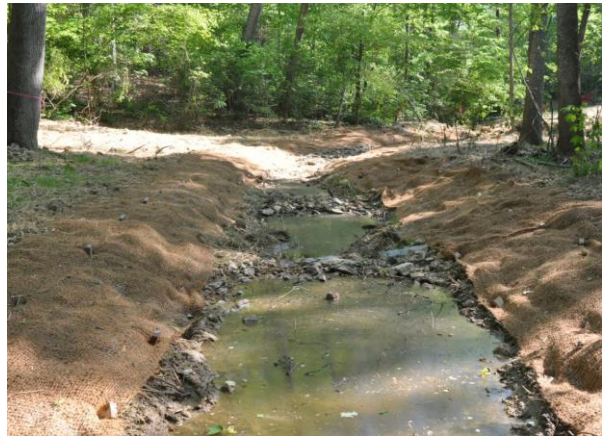
Photograph 4: View of new channel facing downstream

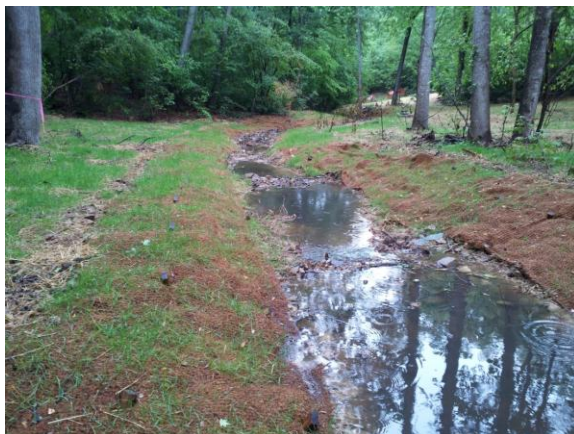
Photograph 5: View of matting after a bankfull event a few weeks after construction

A biodegradable matting (coir) made from coconut fibers was installed along all graded streambanks throughout the project area. The matting was secured with wooden stakes. Temporary and permanent native riparian seed and straw mulch were placed under the matting. The matting provides short term bank erosion protection while the riparian vegetation gets established (photographs 4 and 5)

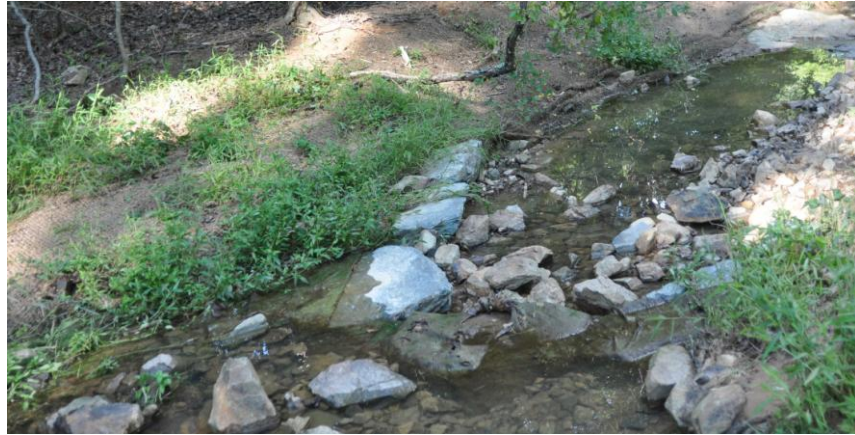
Photograph 6: J-hook boulder structure

Boulder sill structures were constructed in the channel to provide grade control, create bedform diversity, and help maintain pool scour. J-hook boulder vanes were constructed to direct flow away from streambanks while providing grade control and maintaining scour pools (Photograph 6)

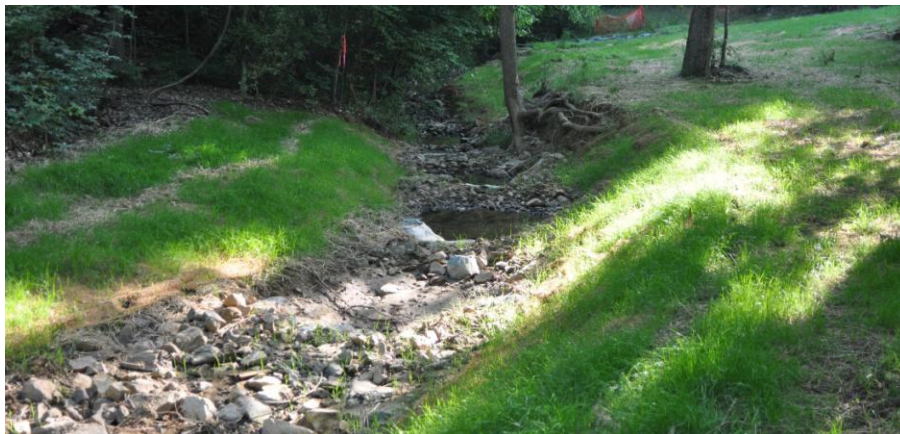
Photograph 7: View of floodplain benches after a bankfull event

Floodplain benches were graded adjacent to the channel in incised areas. Floodplain benches allow flood flows to spread out on a floodplain to dissipate energy and minimize erosion (Photograph 7).

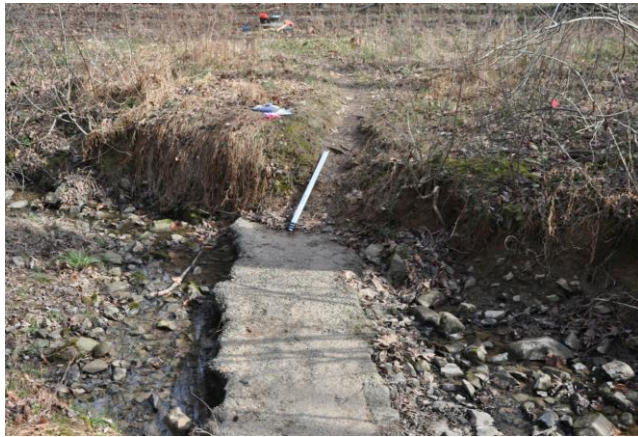
Photograph 8: Eroding sewer crossing before construction

An improved ford was installed at the upstream extent of the project along an eroding sewer easement crossing. The steep and eroding banks were graded to a stable 5:1 side slope and the channel bed was stabilized with a boulder sill and a mix of Class A and Class B stone (Photographs 8 and 9).

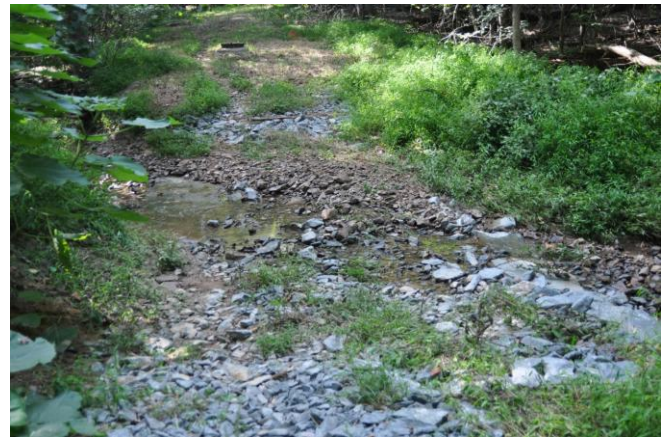
Photograph 9: Stabilized sewer easement crossing

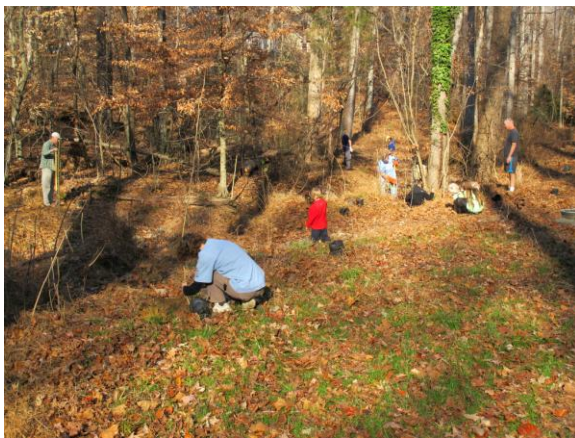
Photograph 10: Plant installation

In December 2012, NCSU staff, Town staff, and about a dozen volunteers installed native riparian plants along the project reach (photographs 10 & 11). The following species were planted: Live Stakes: Silky dogwood, Elderberry, Black willow. Container Plants: Tag alder, River birch, Witch hazel, Sycamore, Swamp chestnut oak, Arrow wood, Dwarf azalea. Plugs: Soft rush, River oats, Cardinal flower.

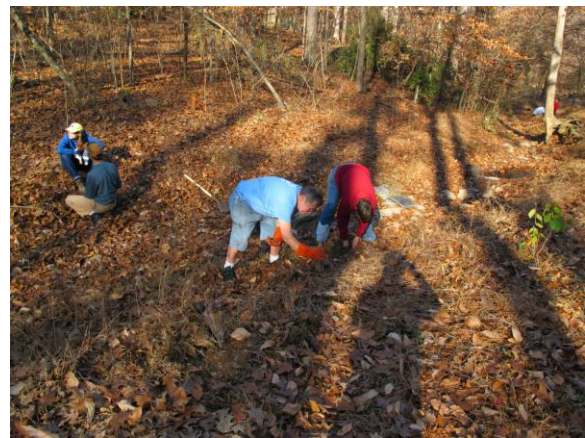
Photograph 11: Plant installation

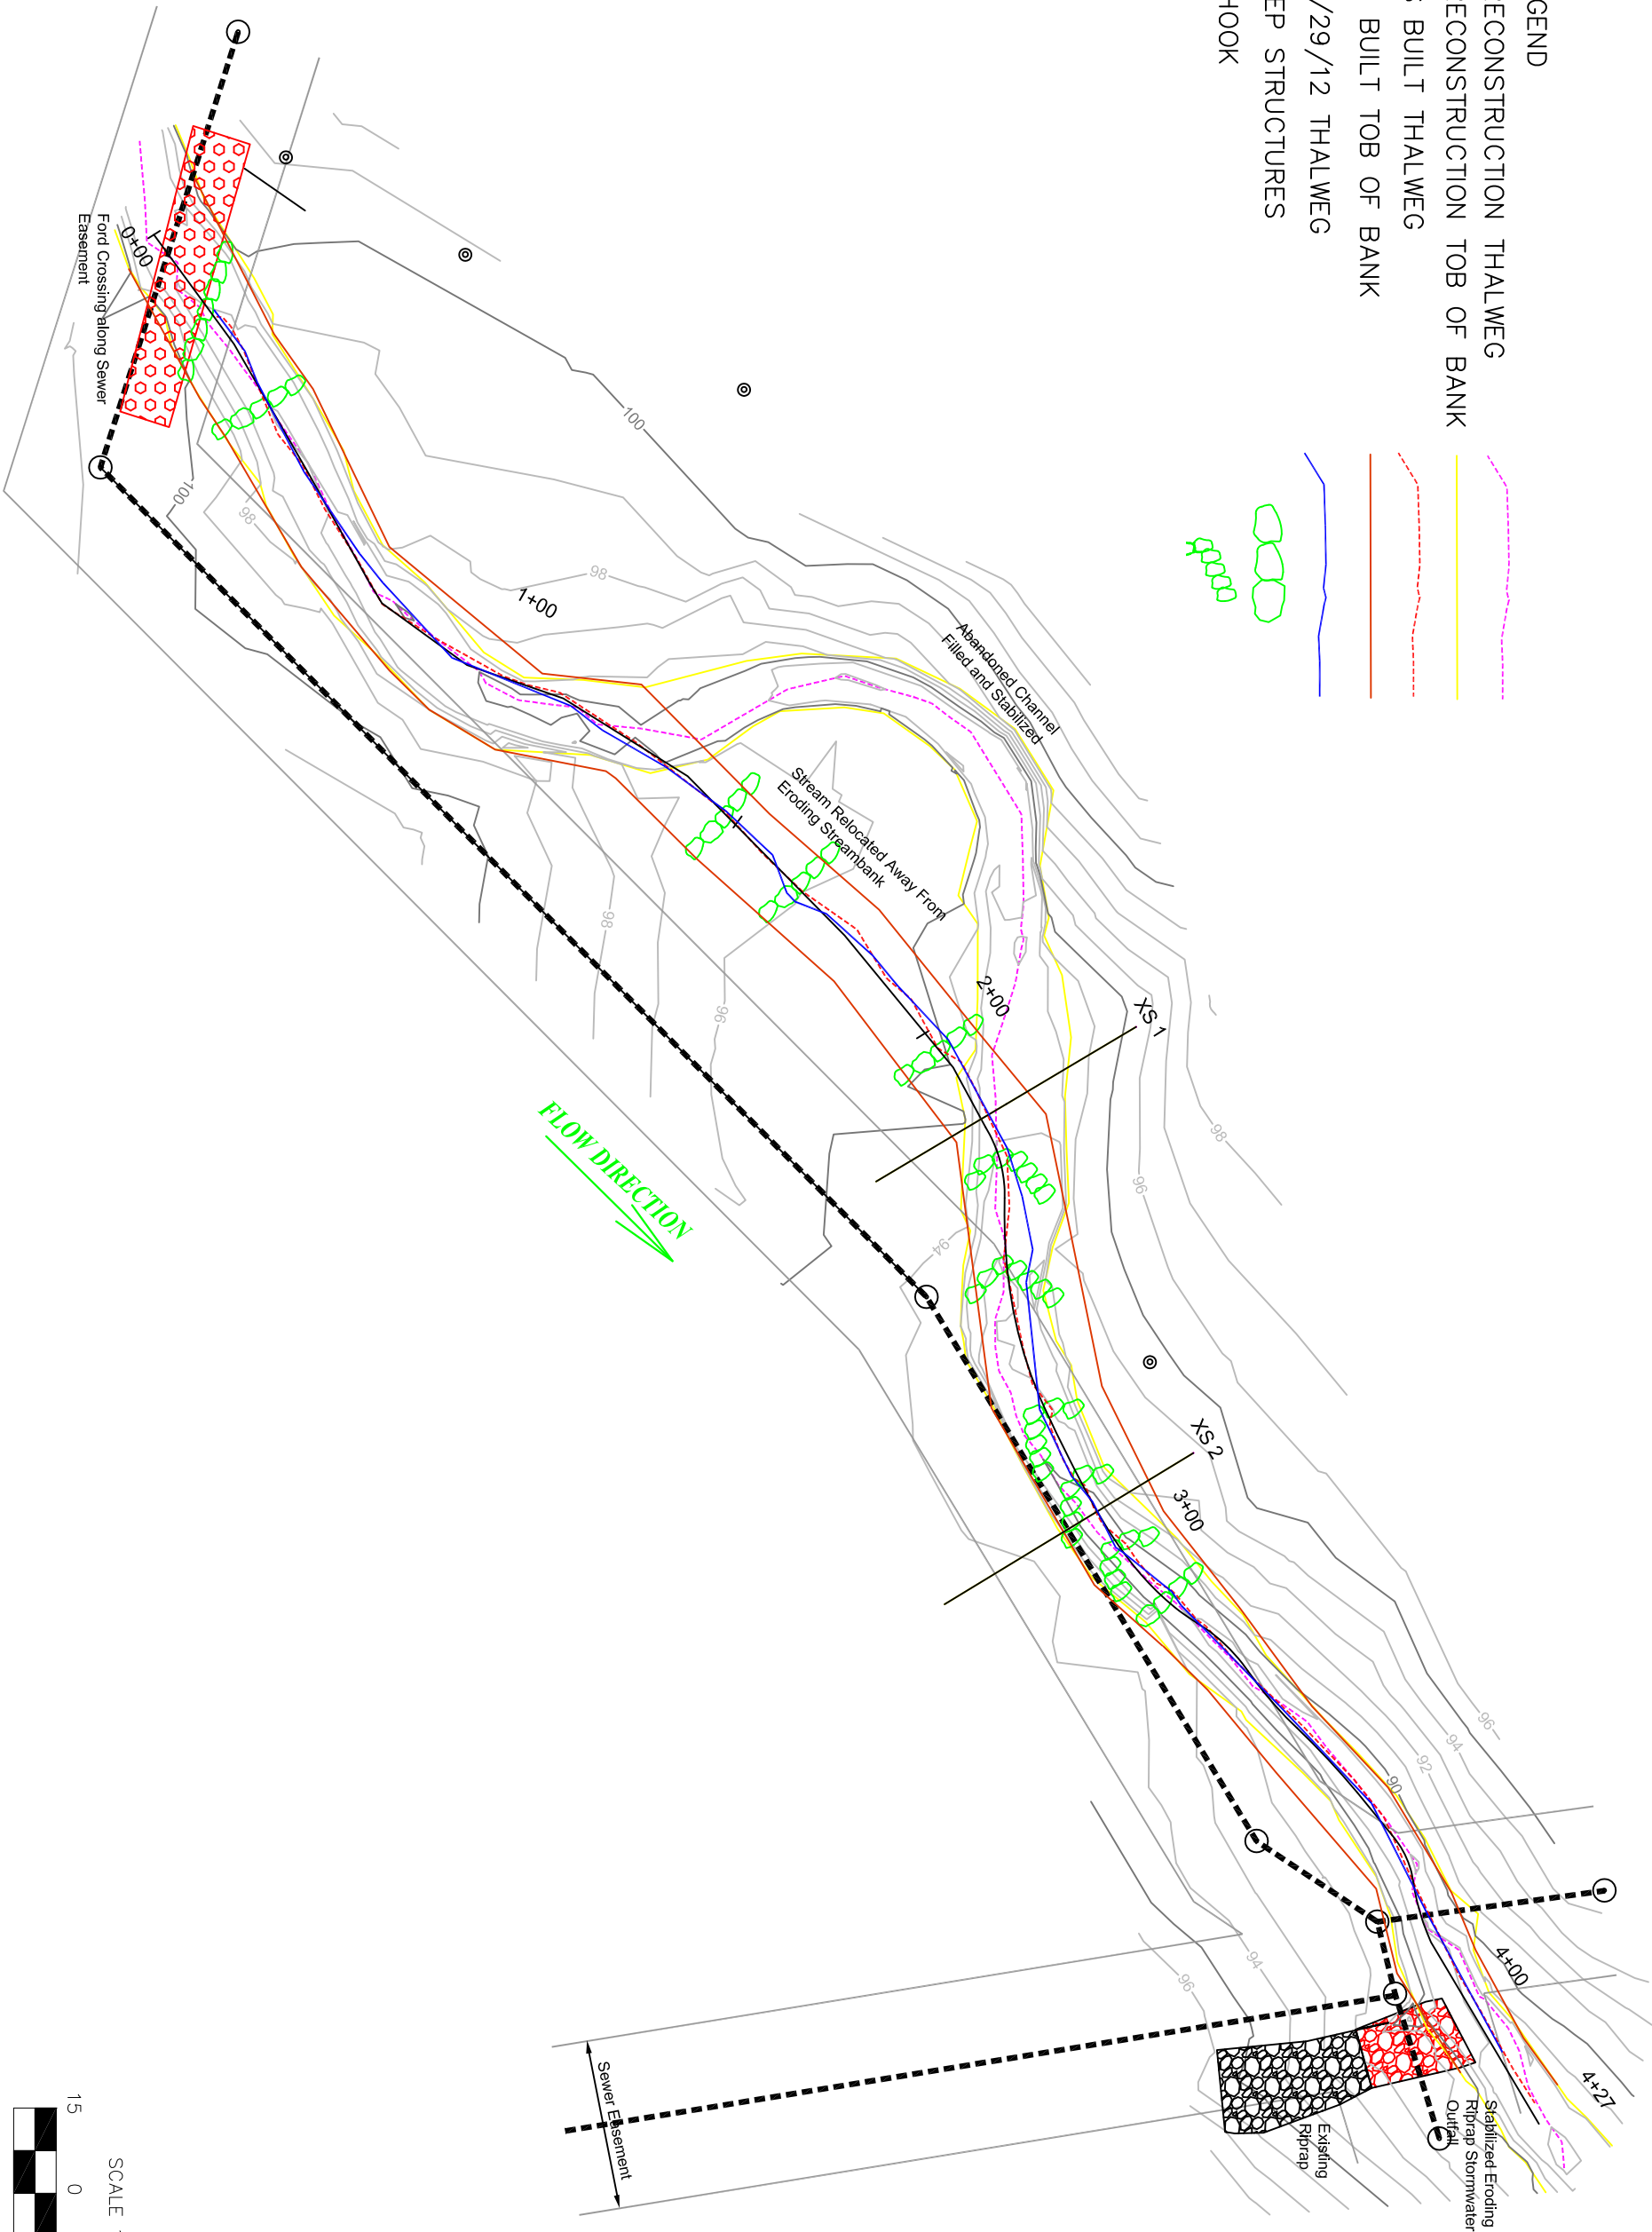
The planform does not show significant changes from the asbuilt condition. The November thalweg measurement shifted slightly to the left between Stations 2+25 to 2+65 when compared to the asbuilt position. The two j-hook structures in this location should keep the stress off of the left bank.

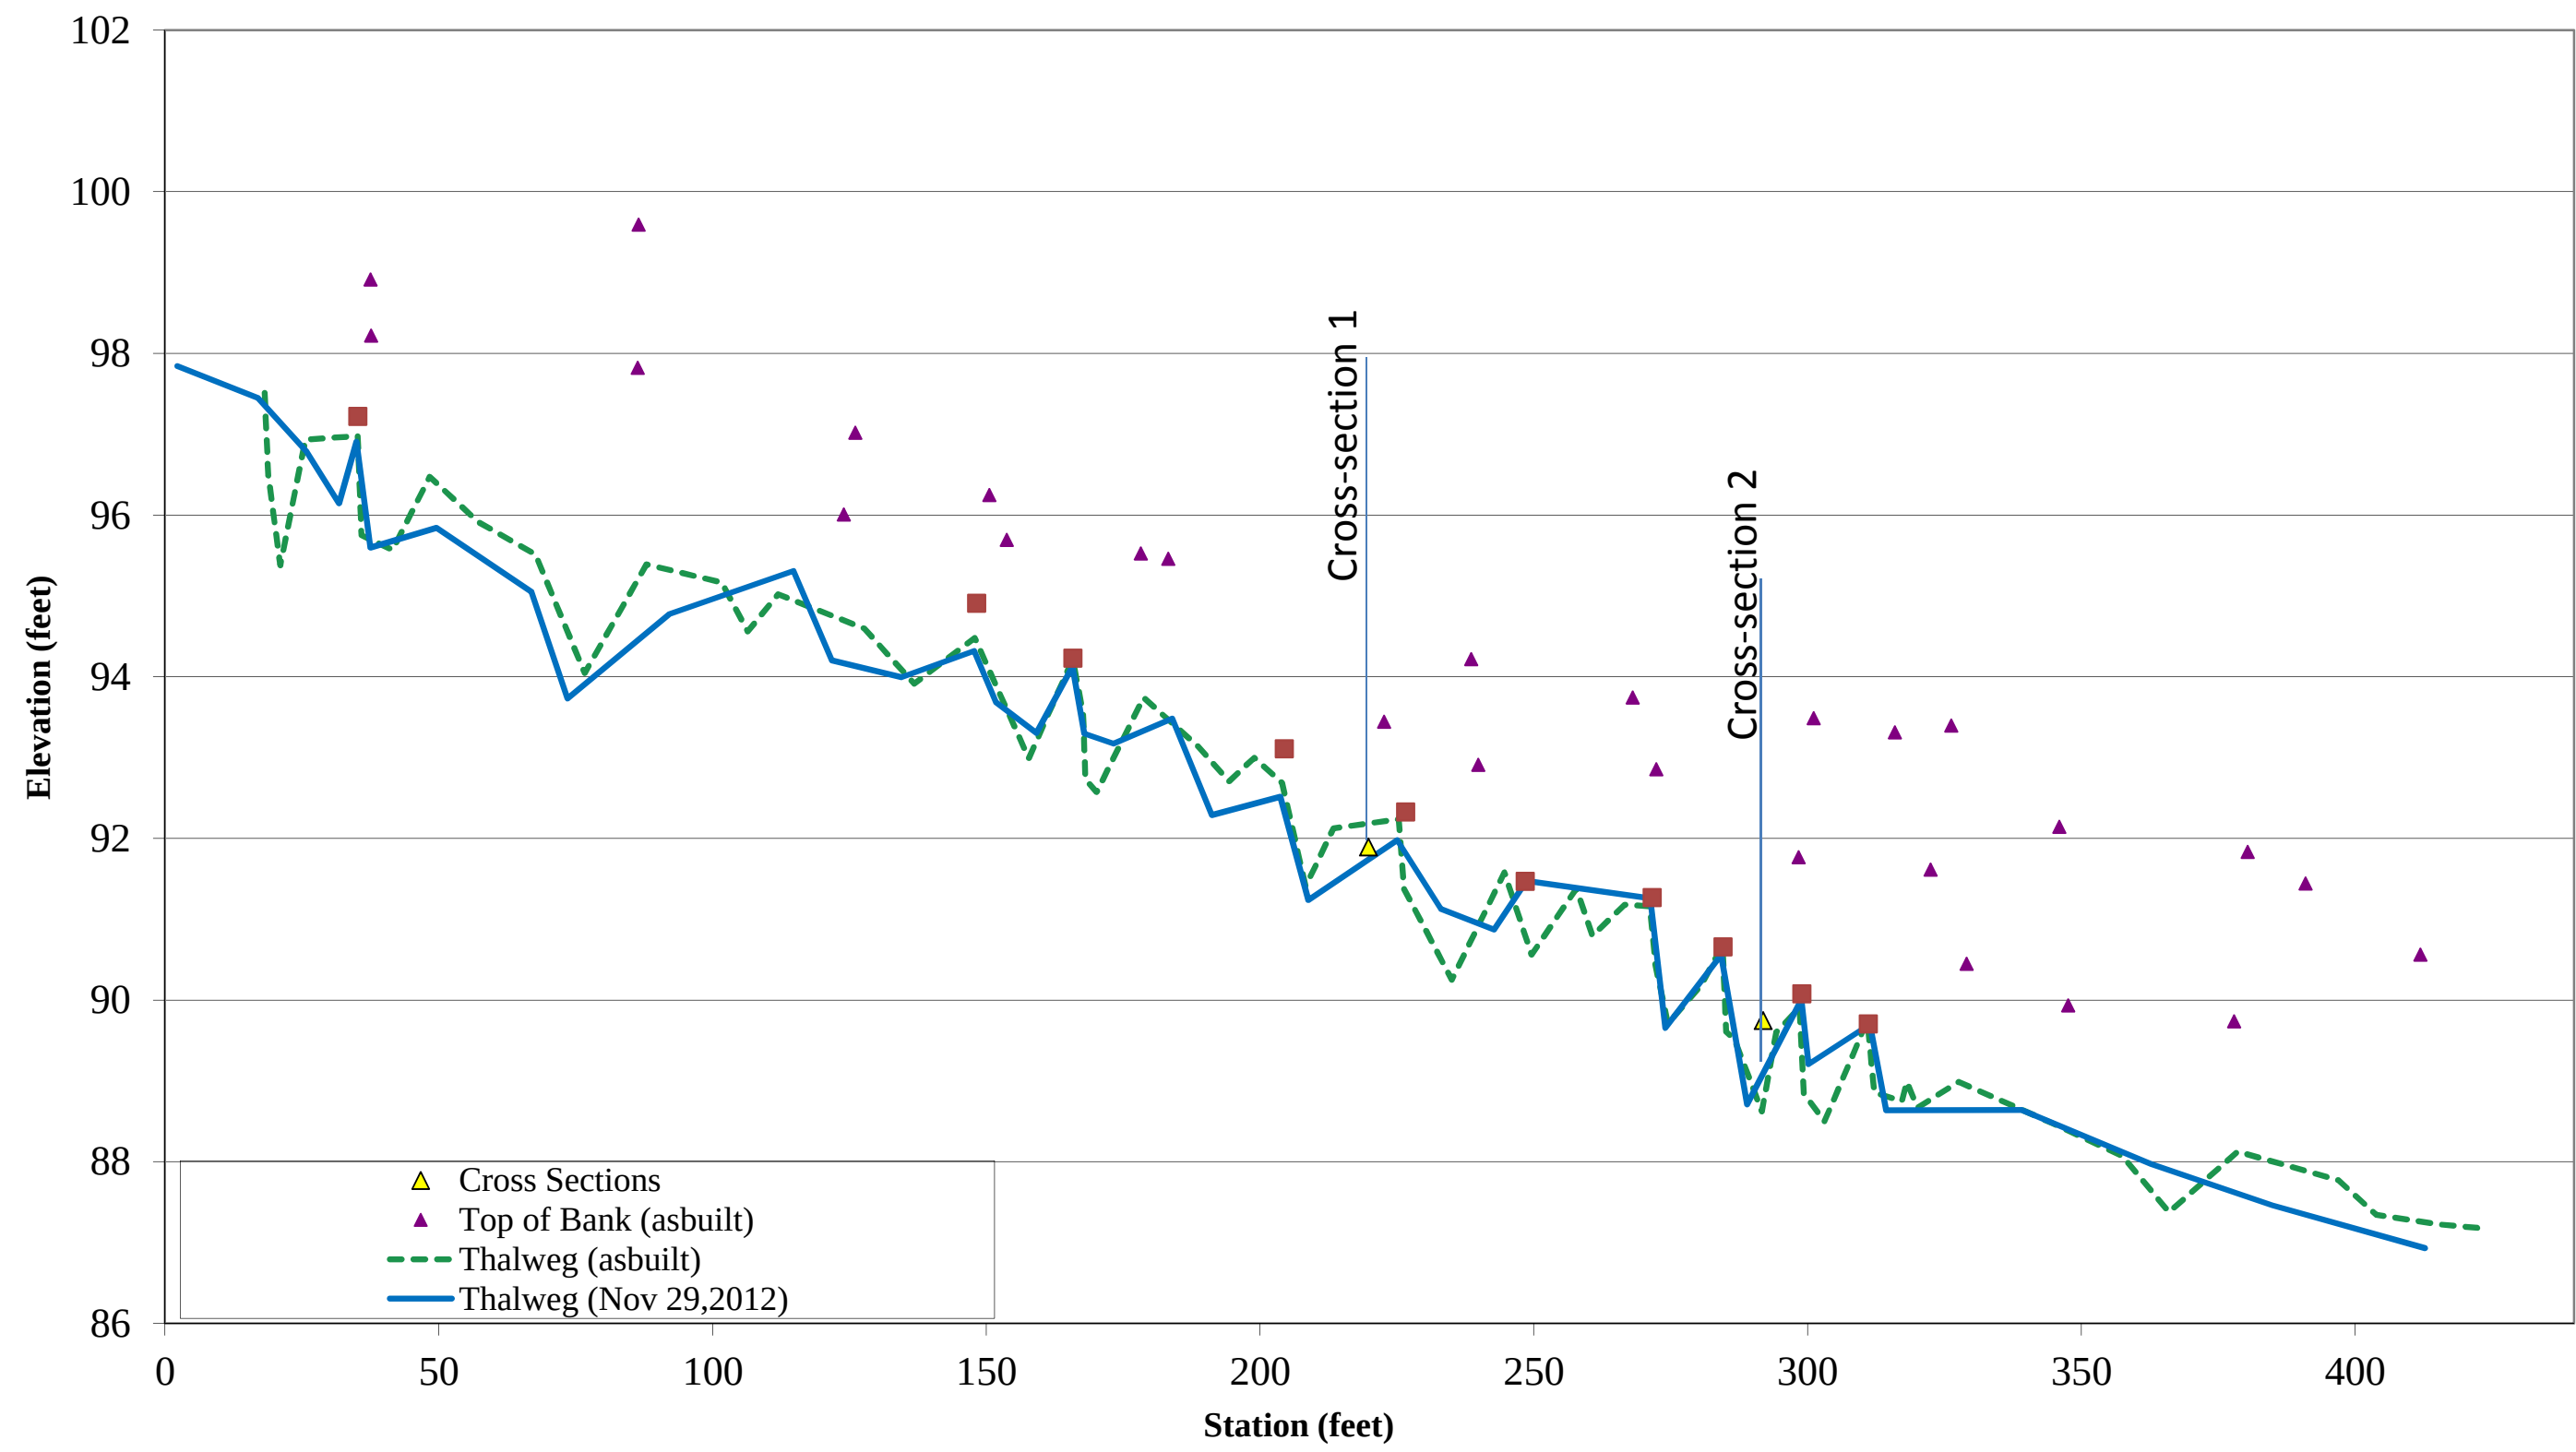
Dry Gulch Longitudinal Profile

The longitudinal profile also does not show significant changes from the asbuilt condition. Some minor bed scour occurred at the upstream portion of the reach and below a bedrock riffle in the middle portion of the reach. Minor bed adjustments are expected in natural stream systems. Additionally, the boulder step structures are designed to maintain and scour out the pools.

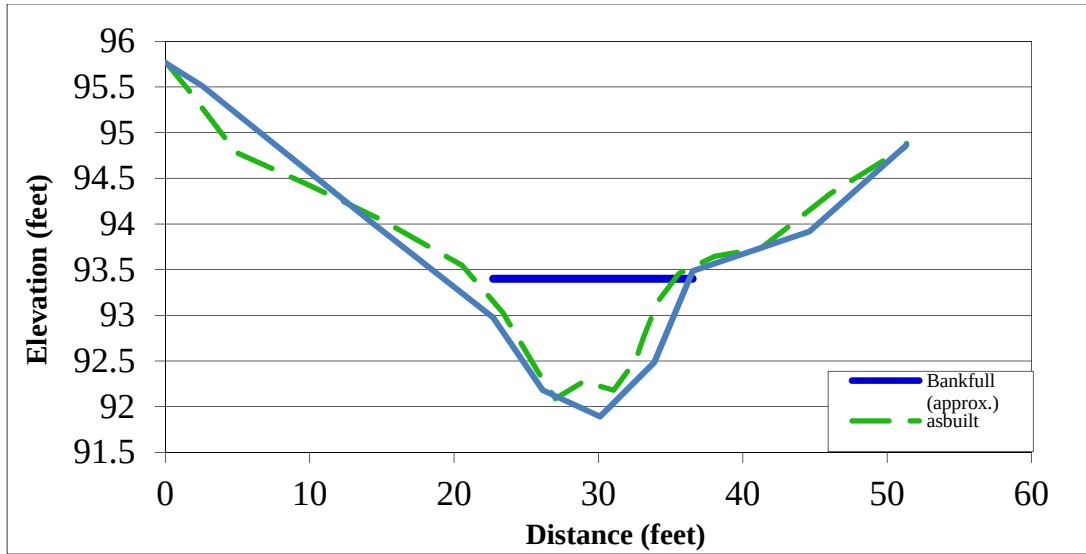
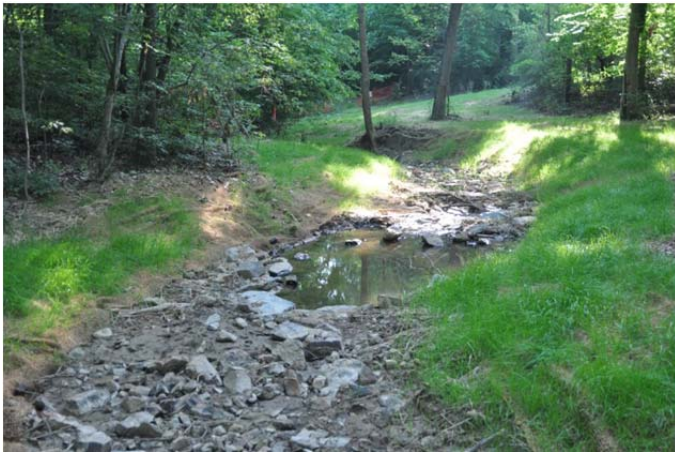
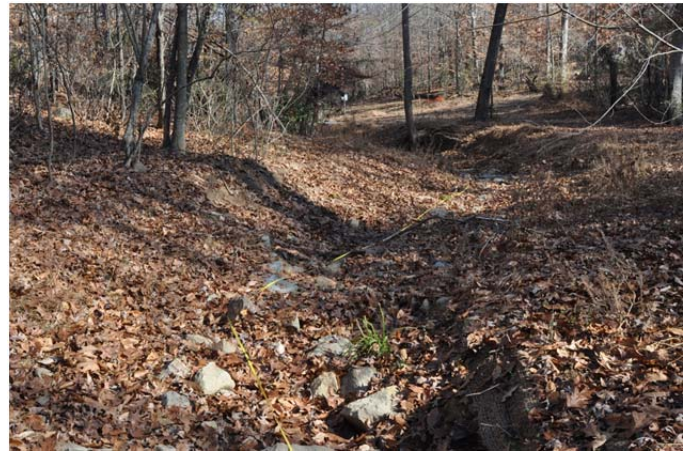
## Cross Section 1 – Dry Gulch

The area, width, and depth of both cross sections increased from the asbuilt survey to the November survey. Some channel dimension adjustment is expected in the short term after construction. The cross sections should stabilize once permanent vegetation becomes established. Streambank slopes remained stable and no erosion was observed in the field along the cross sections.
