# FINAL REPORT

## Dry Gulch Stream Restoration

Biological and Agricultural Engineering Department  
North Carolina State University  
Raleigh, North Carolina

Town of Carrboro  
Carrboro, North Carolina

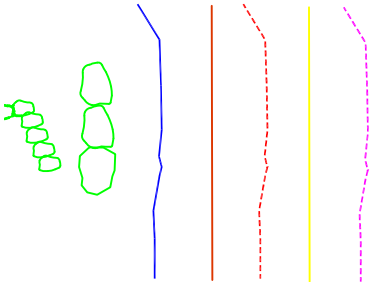
J HOOK

The planform does not show significant changes from the asbuilt condition. The November thalweg measurement shifted slightly to the left between Stations 2+25 to 2+65 when compared to the asbuilt position. The two j-hook structures in this location should keep the stress off of the left bank.
