BIOLOGICAL MONITORING OF BOLIN CREEK CARRBORO, NORTH CAROLINA April - July 2022

Eaton Scientific
2105 Osprey Circle
Raleigh, NC 27615
919 602-0757

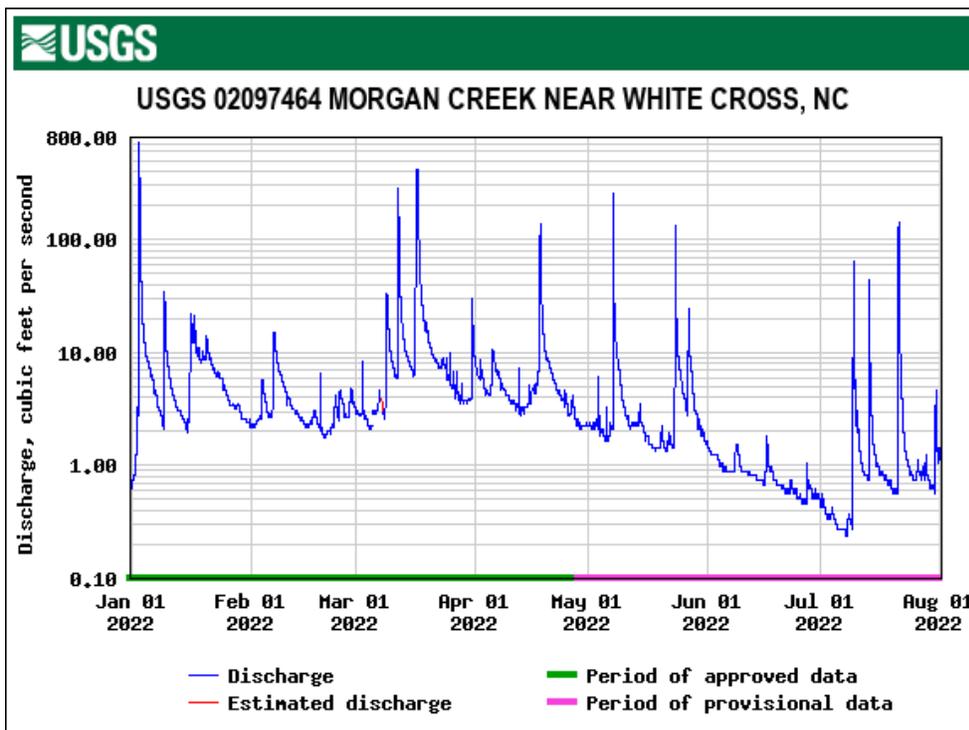
USGS Daily discharge data Jan-July 2022 from Morgan Creek nr White Cross.

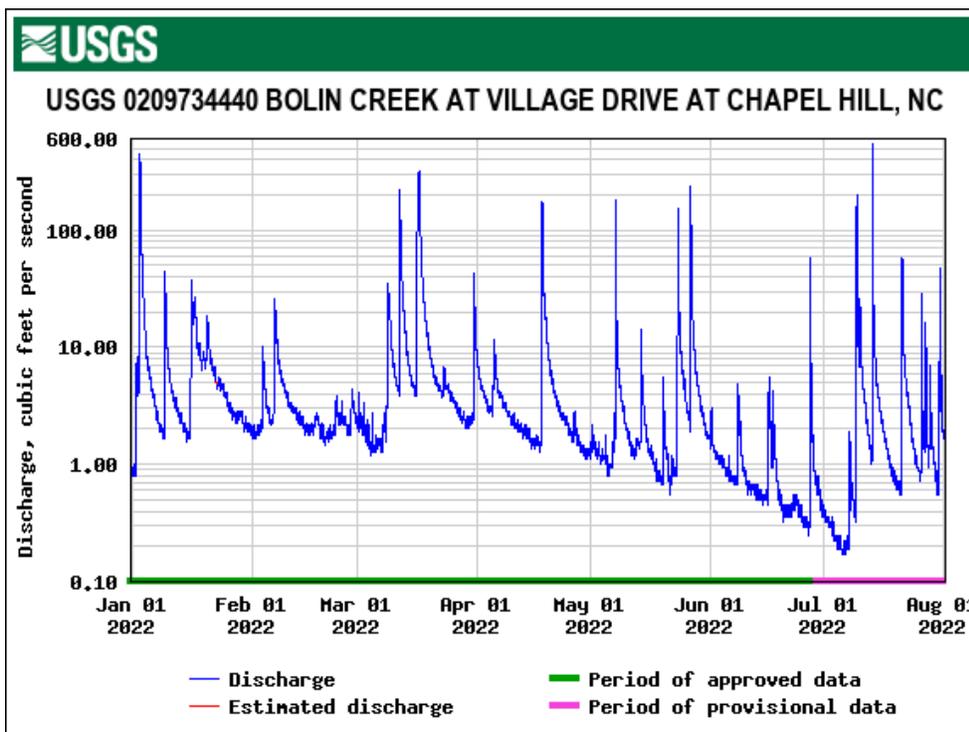
USGS daily discharge data, Jan-July 2022 from Bolin Creek at Village Drive.

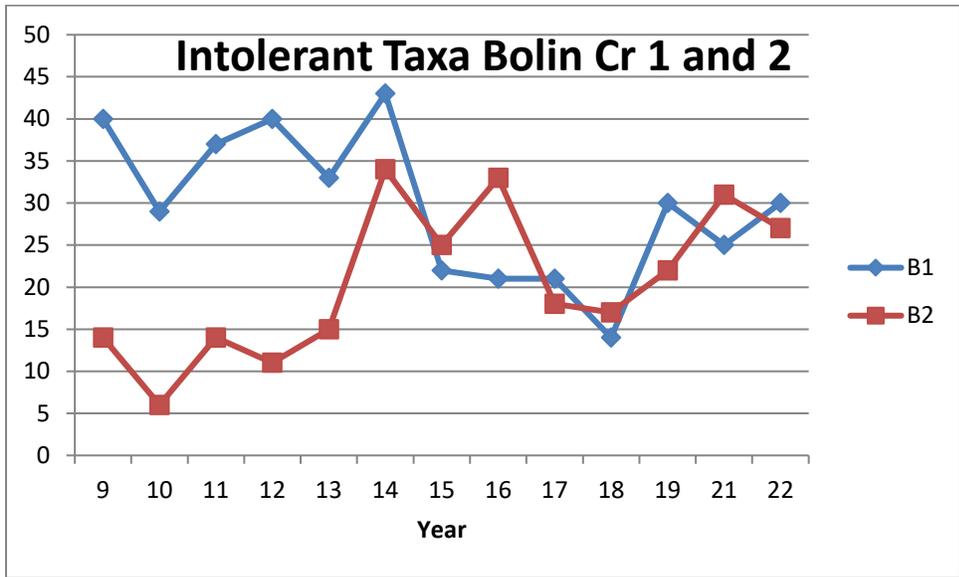
Figure 1. Intolerant taxa richness Bolin Cr 1 and Bolin Cr 2, 2009-2022.

years, is further evidence of recent water quality problems upstream of Bolin Creek Site 1. Figures 1 and 2 are a graphical summary of the data shown in these appendices that more clearly shows the declining water quality from Bolin Cr 1 affecting the water quality in Bolin Cr 2. Bolin Cr 3 is surprisingly stable, while Bolin Cr 4 showed some signs of possible recovery until 2019, when the number of selected intolerant taxa dropped by over 50% from 2018. Intolerant taxa at Bolin 4 continued its decline in 2021 then rebounded in 2022.

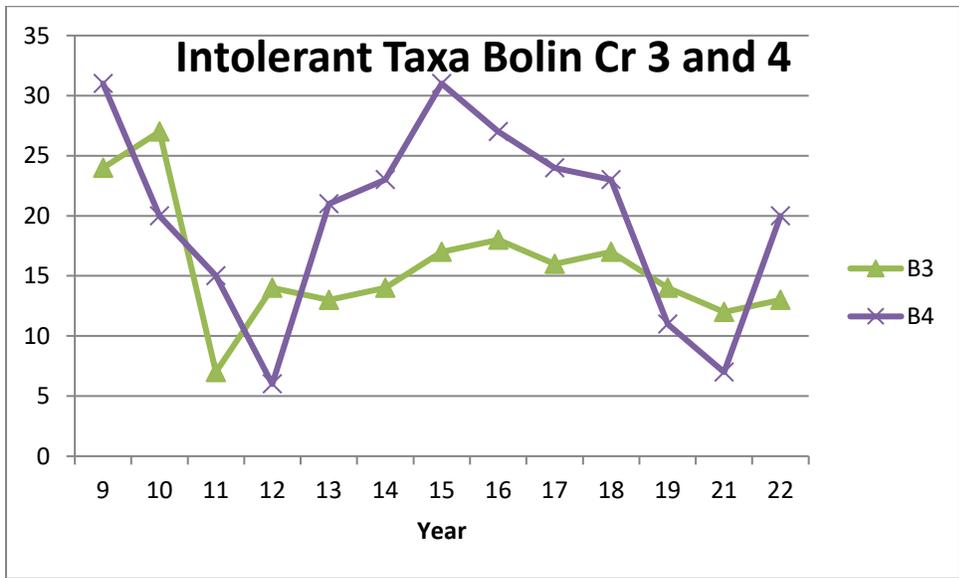
Figure 2. Intolerant taxa richness Bolin Cr 3 and 4, 2009-2022.

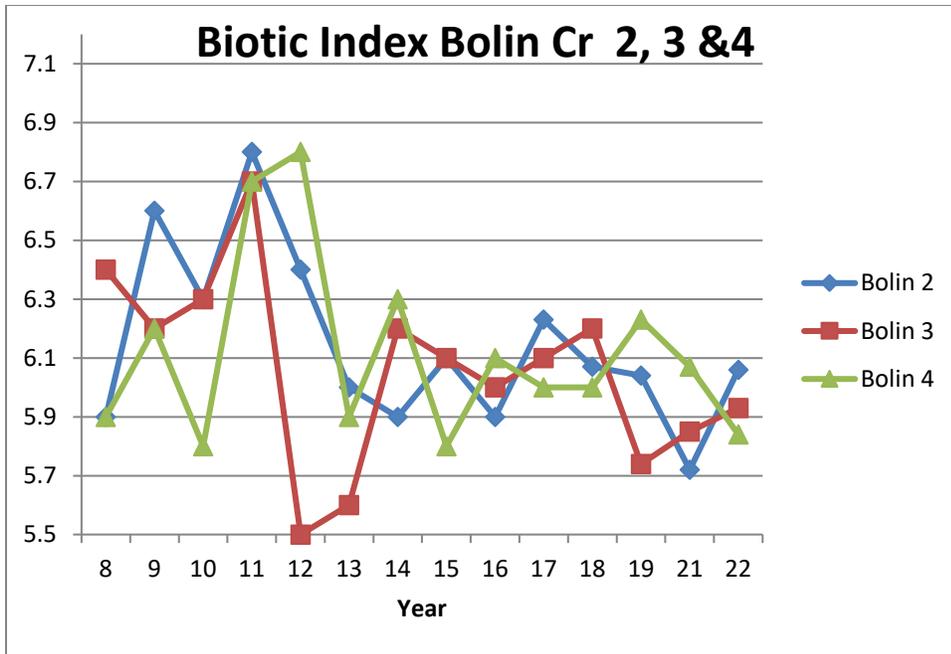
Figure 3. Biotic Index over time for Bolin sites 2, 3 & 4.

Figure 3 is a summary of the Biotic Index at the lower three Bolin Creek sites since 2008. There appears to be a wide variety of Biotic Index values during the very low flow/drought years of 2008-2012. Since the series of drought years ended, these areas further downstream are usually rated as Fair, with Biotic Index values confined to a fairly narrow range of 5.8-6.3. Both Sites 3 and 4 are intermediate between a Fair and a Good-Fair rating, and would be assigned Good-Fair ratings based solely on Biotic Index values. A very small improvement, in the case of Site 4 a single additional EPT, might bring both sites up to a level that indicates they are “sustaining designated uses”.

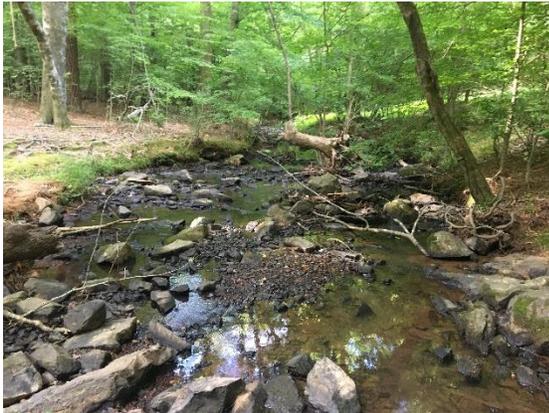
Bolin Creek Site 1 July 2022

This part of Bolin Creek averaged about 4-5 meters wide, with a substrate mainly composed of gravel and rubble. Both the substrate composition and the width, however, were highly variable. There were no significant habitat problems in this section of Bolin Creek, although 2015 samples suggest some water quality problems.

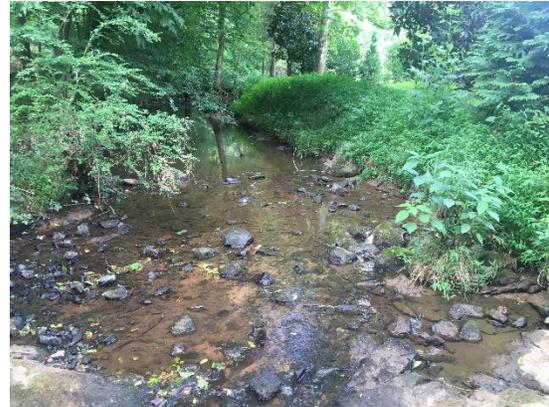
Bolin Creek Site 2, July 2022.

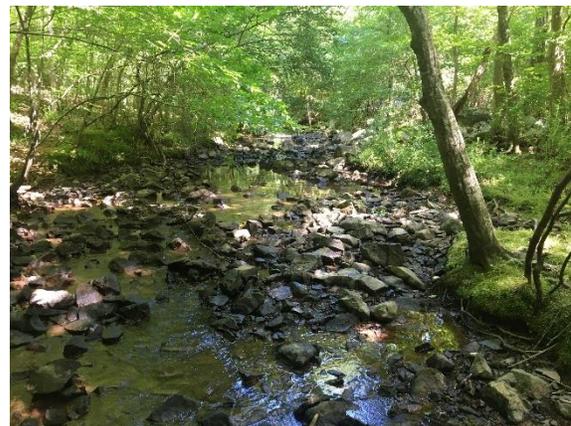
Bolin Creek Site 3, July 2022.

There are no significant habitat problems in this portion of the stream, but there was a lack of good bank habitat and large sections of the stream were not flowing.

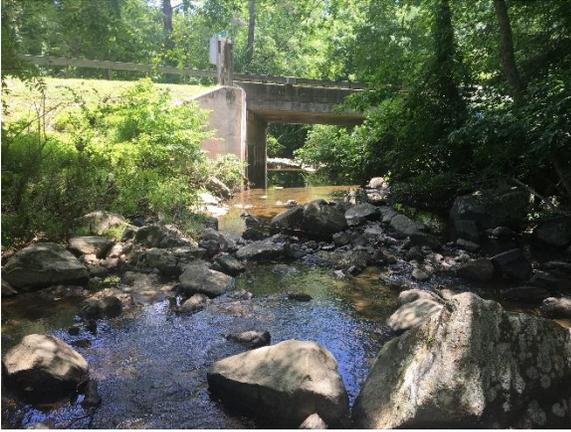
Bolin Creek Site 4, July 2022.

This portion of Bolin Creek is similar to the site on Estes Drive, having good rocky substrate and was six meters wide. Attached filamentous algae was very abundant at the Village Drive site in March 2011, but has not been a problem in later years.

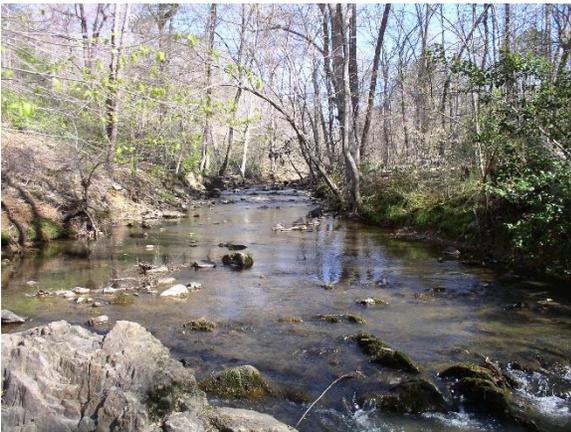
Morgan Creek Site 1, April 2022.

This catchment has a largely rural character, with some minor impacts from nonpoint source runoff. Habitat quality, stream width and substrate composition are similar to Bolin Creek, but with less residential land use. Residential land use, however, has been increasing in the Morgan Creek catchment in recent years.
